# **PHASE I ENVIRONMENTAL SITE ASSESSMENT**

**SANDOVAL COUNTY  
529 ACRES OF RURAL PROPERTY  
SECTION 36, SANDOVAL COUNTY, NEW MEXICO**

**JANUARY 7, 2025**

# PHASE I ENVIRONMENTAL SITE ASSESSMENT REPORT

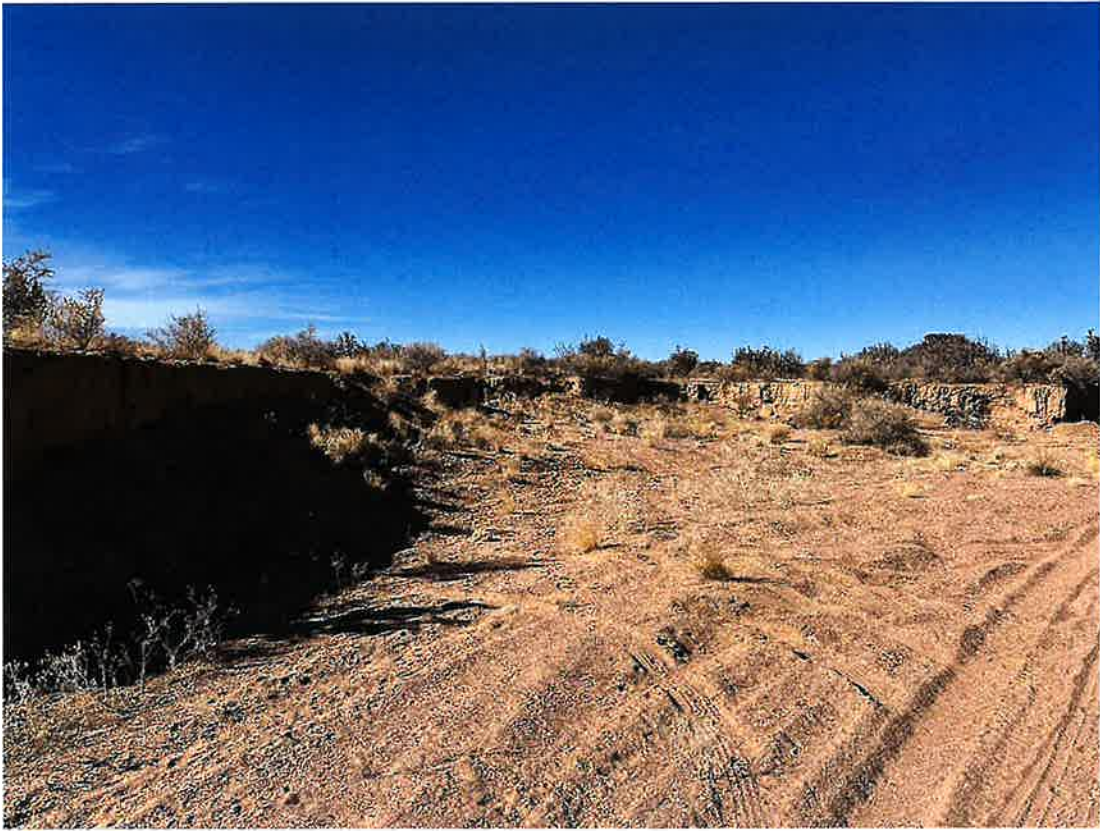
*Photo 51. Main arroyo of subject property western channel walls, looking northwest*

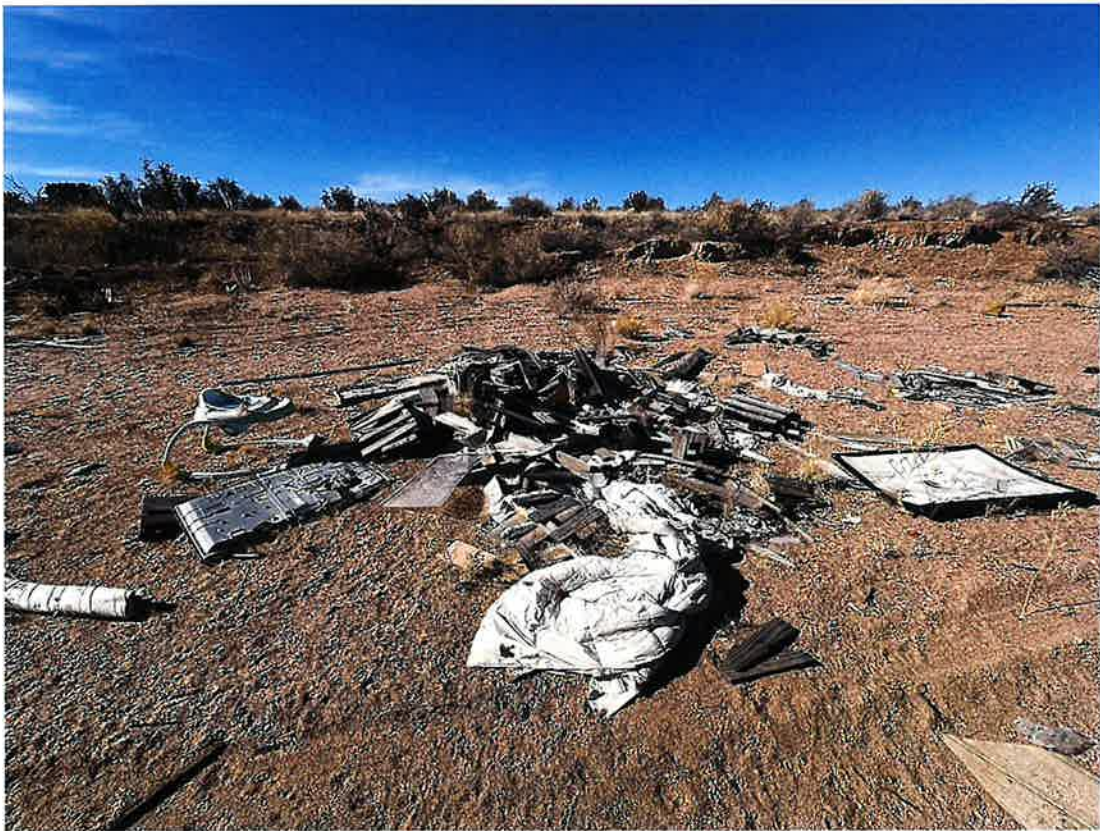
*Photo 52. Solid waste observed in main arroyo at interior of subject property in southeast portion, view to west*

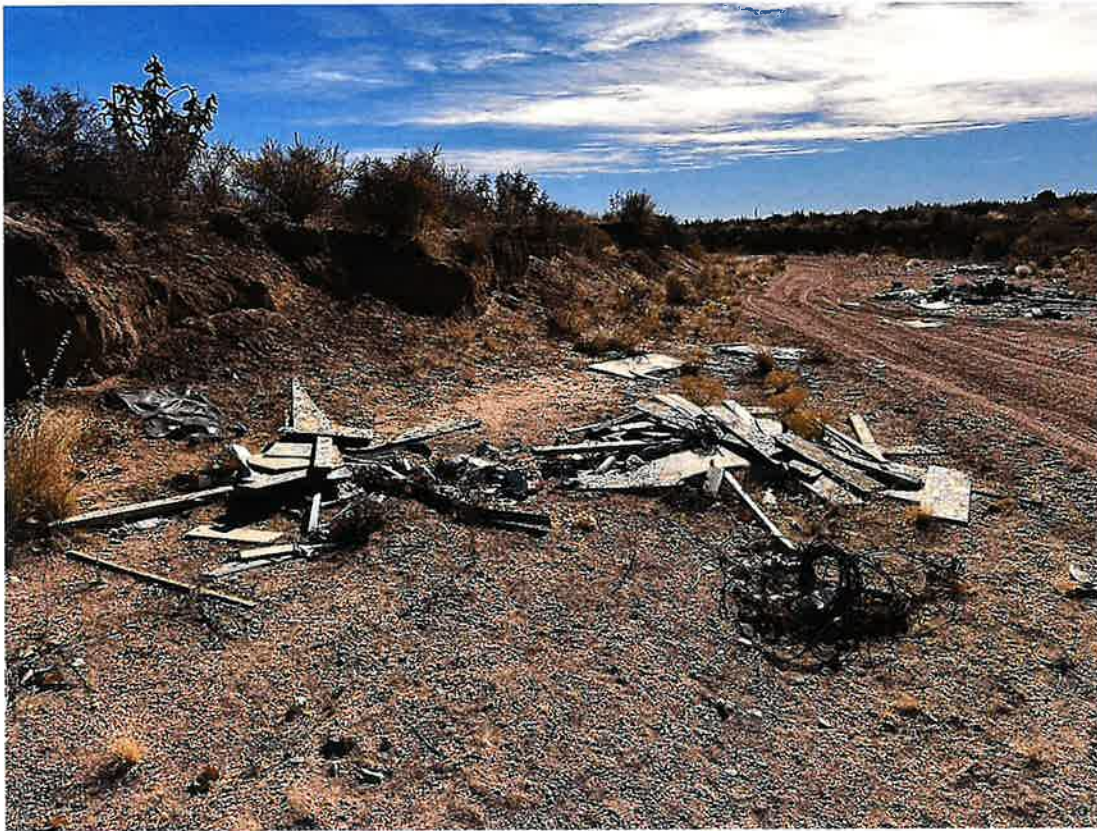
*Photo 53. Solid waste piles observed in main arroyo in interior of subject property in southeast portion, looking southeast*

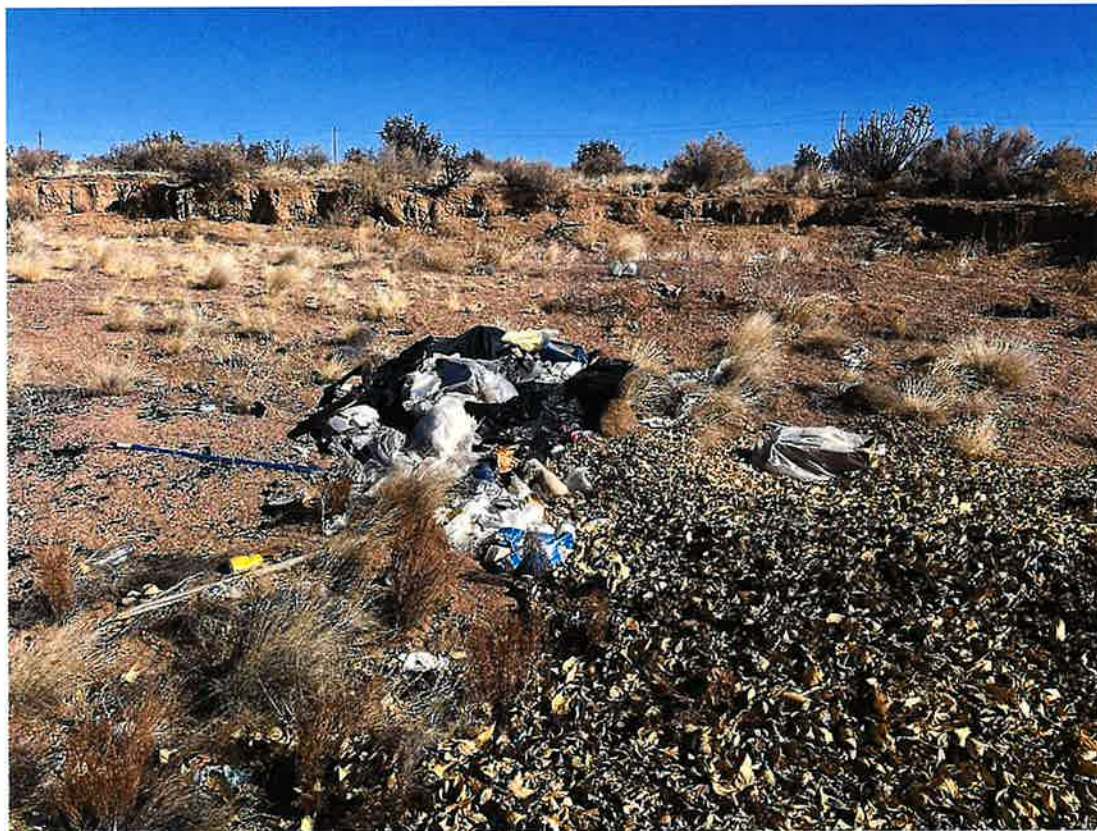
*Photo 54. Solid waste piles observed in main arroyo in interior of subject property in southeast portion, looking east*

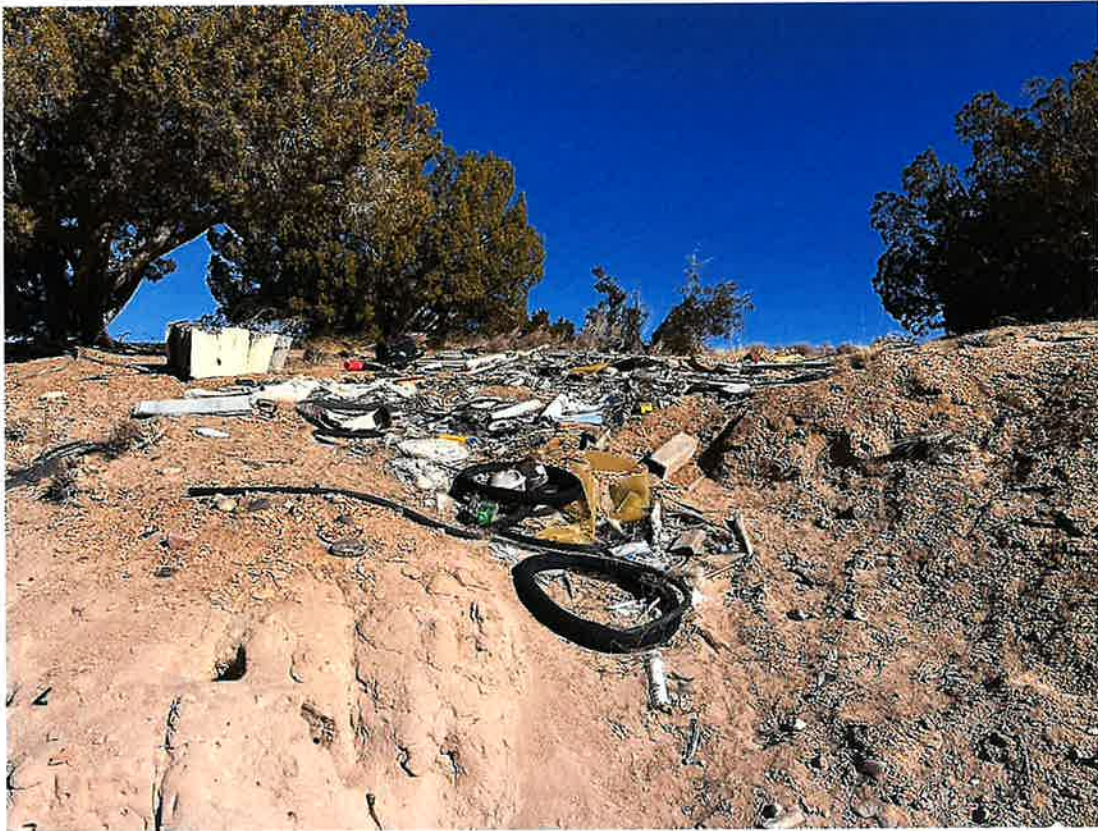
*Photo 55. Solid waste piles observed on southwest corner of subject property, looking northeast*

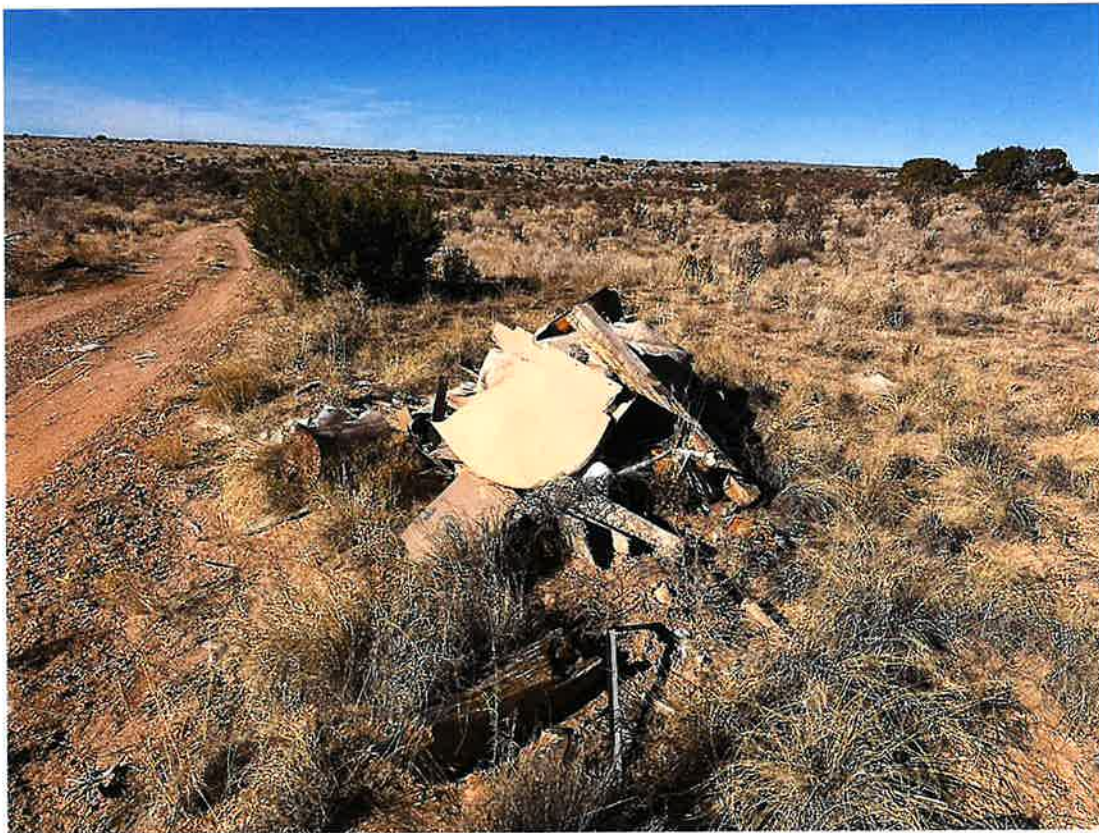
*Photo 56. Solid waste piles observed on eastern portion of subject property, east of 20<sup>th</sup> St NW, looking west*

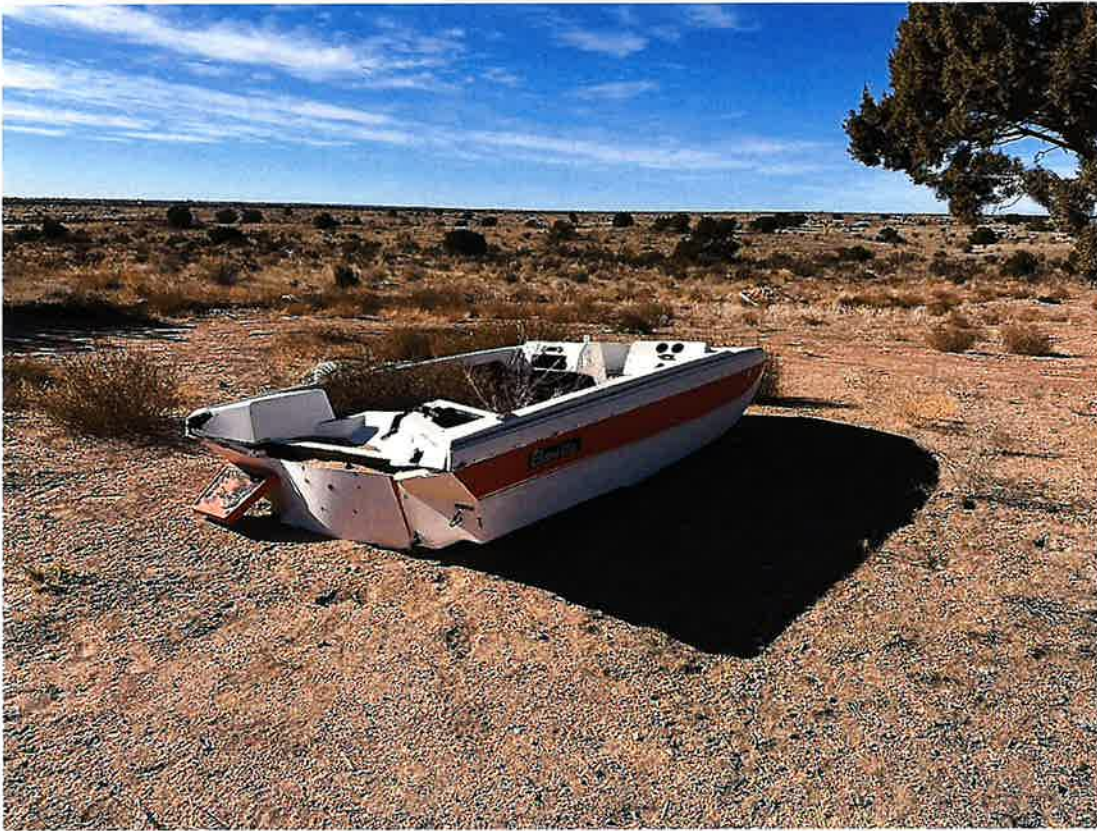
*Photo 57. Abandoned boat on eastern portion of subject property, east of 20<sup>th</sup> St NW, looking west*

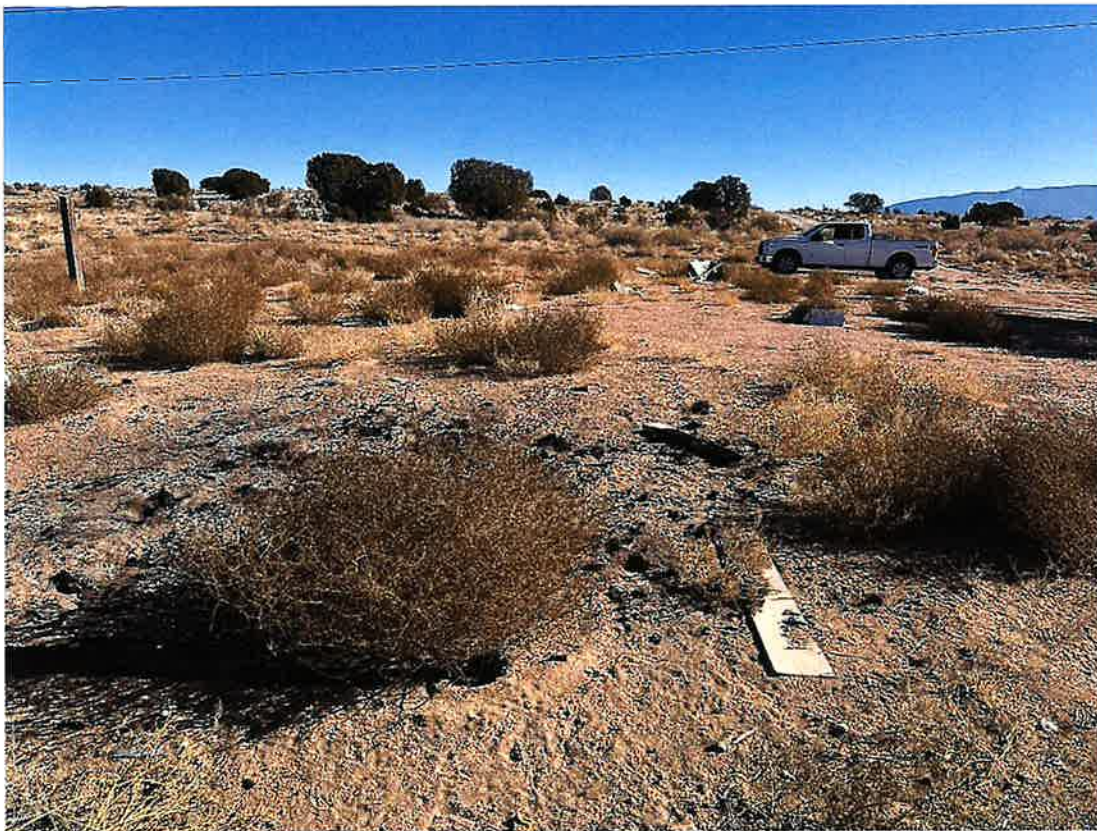
*Photo 58. Burned material in interior of subject property in southeast portion, looking east*

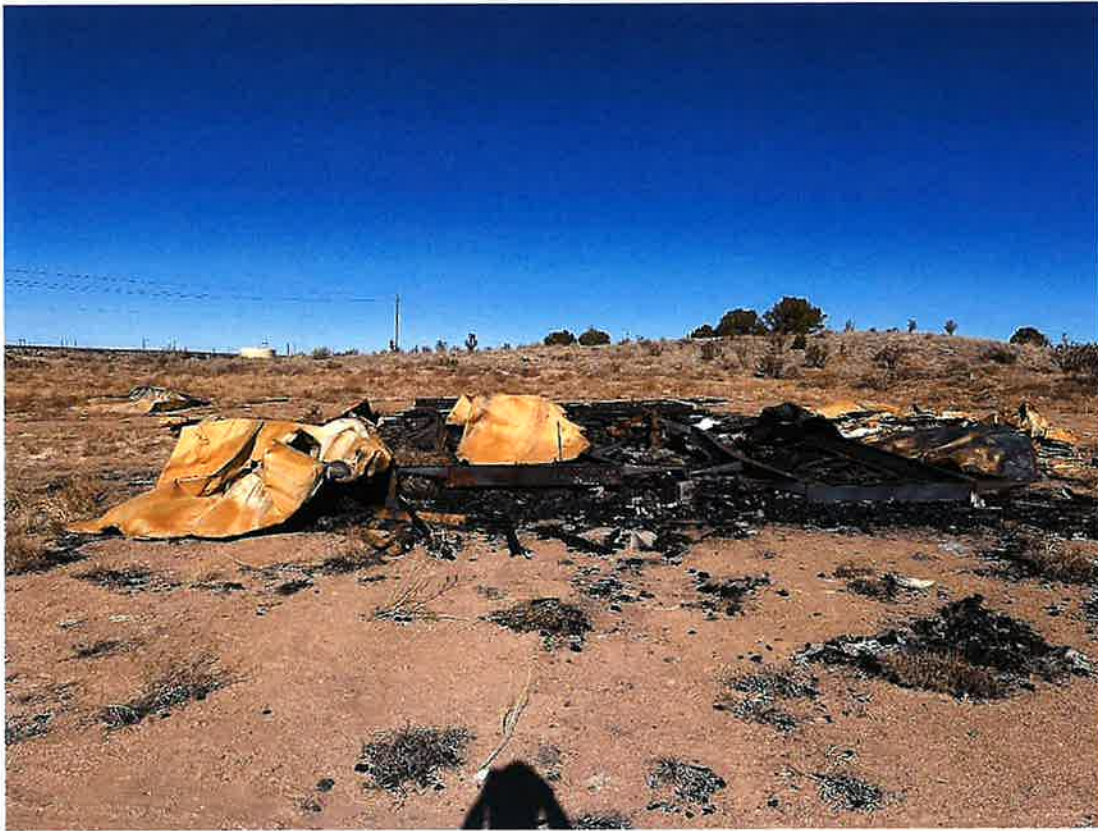
*Photo 59. Burned structure in interior of subject property, east of 20<sup>th</sup> St NW in northeast portion, looking north*

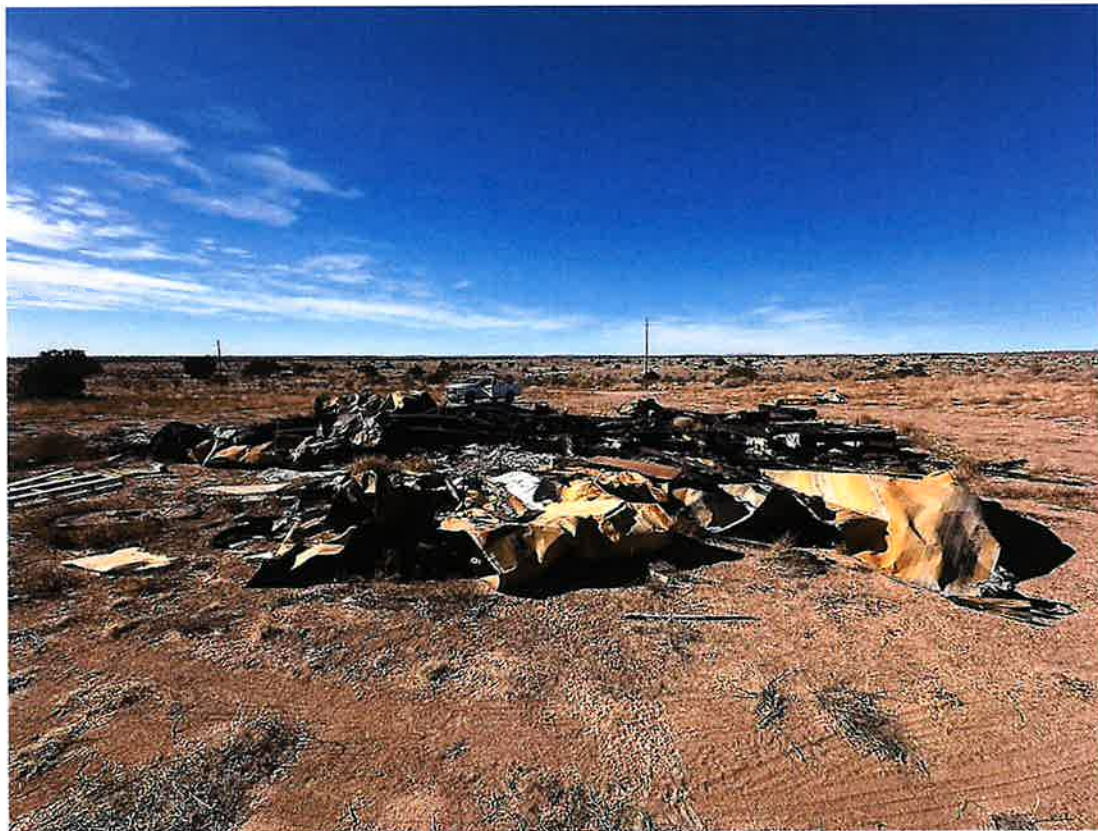
*Photo 60. Burned structure in subject property, east of 20<sup>th</sup> St NW, looking southwest*

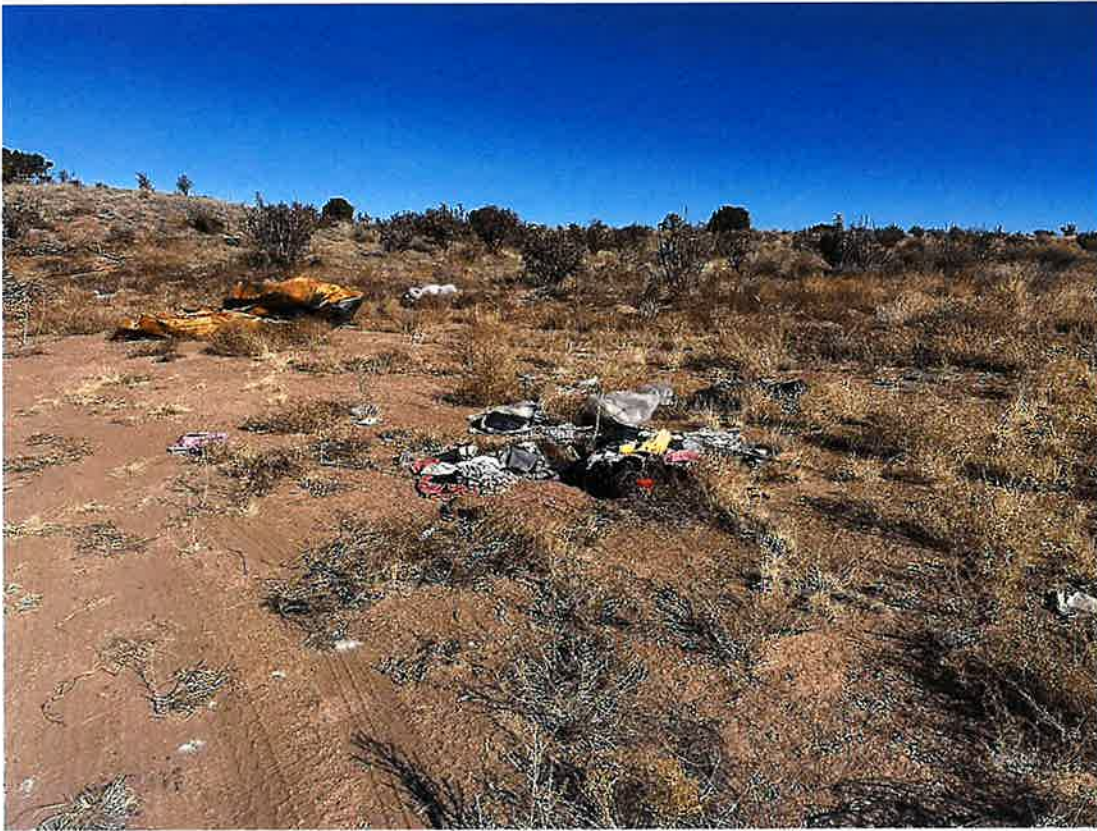
*Photo 61. Solid waste near burned structure, east of 20<sup>th</sup> St NW, looking northeast*

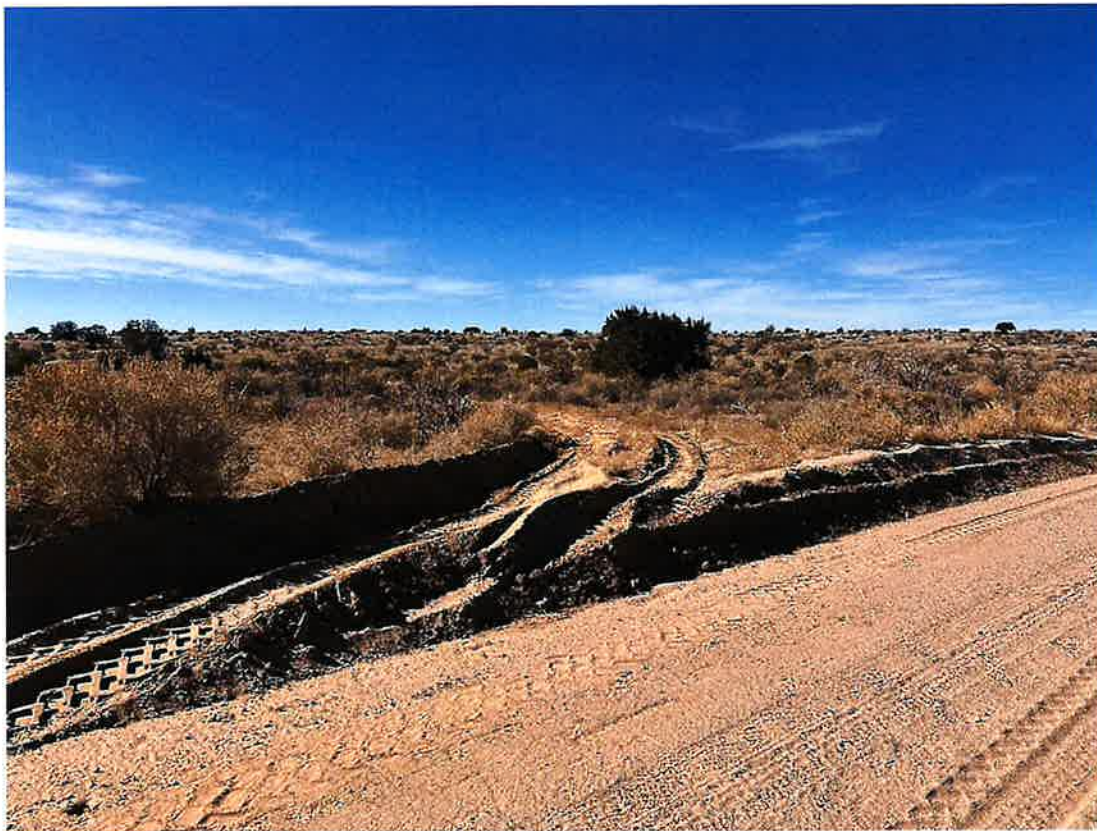
*Photo 62. Erosion control along northern boundary of subject property, looking southwest along King Blvd NW*

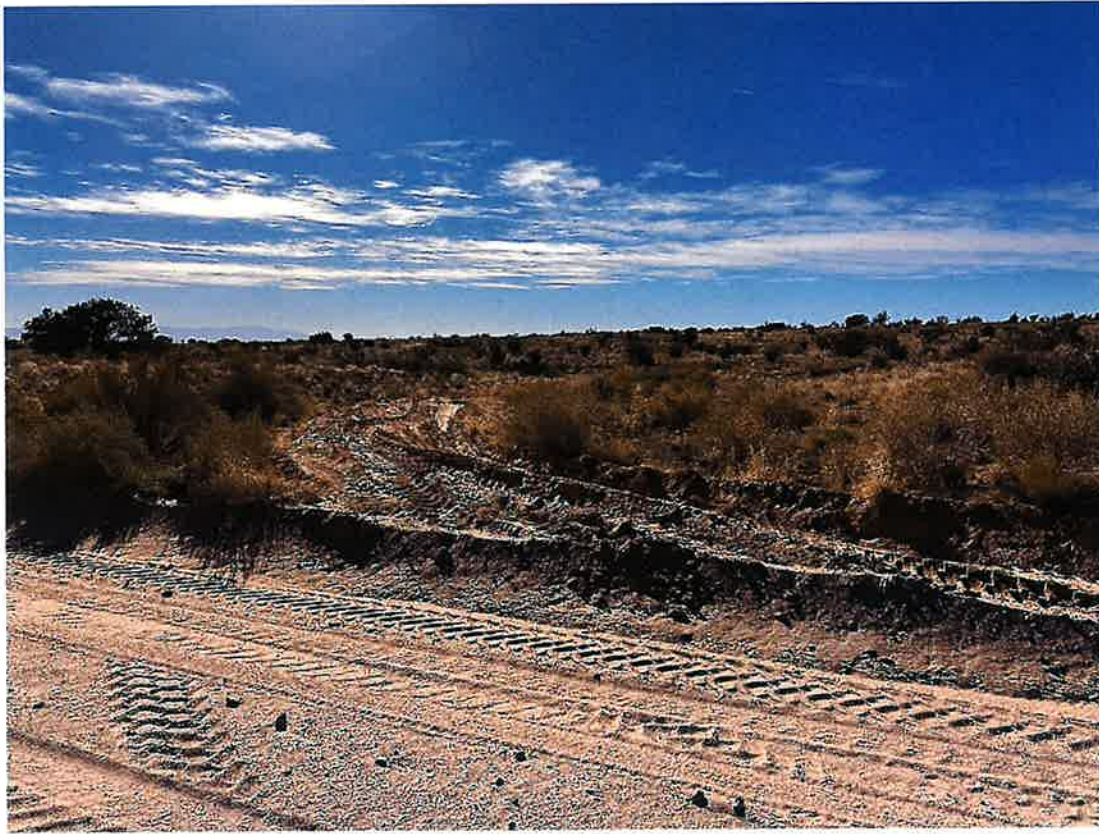
*Photo 63. Erosion control along northern boundary of subject property, looking southeast on King Blvd NW*

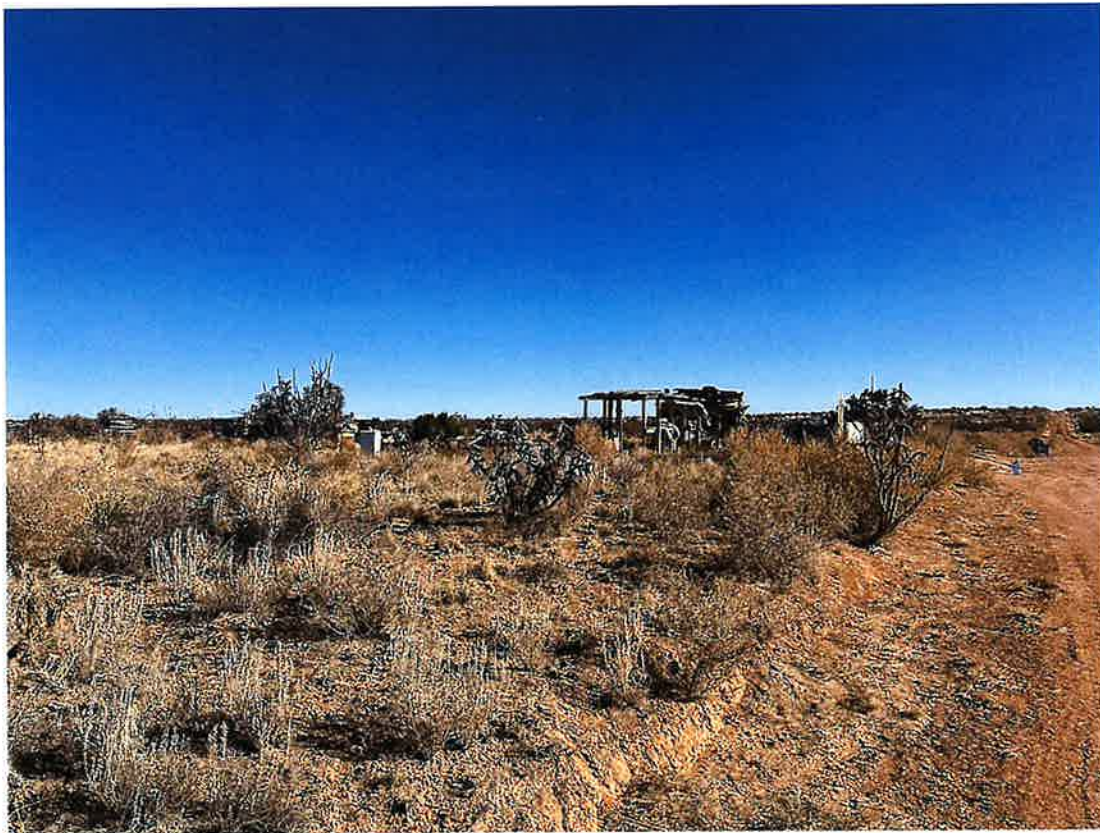
*Photo 64. Persons living on east adjoining property to the subject property at 33<sup>rd</sup> Ave NW, looking east*
